## DEVELOPMENT OF PASSIVE HIGH PRESSURE GAUGES—FIELD EXPERIMENT

General Electric Company—TEMPO  
Center for Advanced Studies  
816 State Street  
Santa Barbara, California 93102

31 January 1979

Final Report for Period May 1978—January 1979

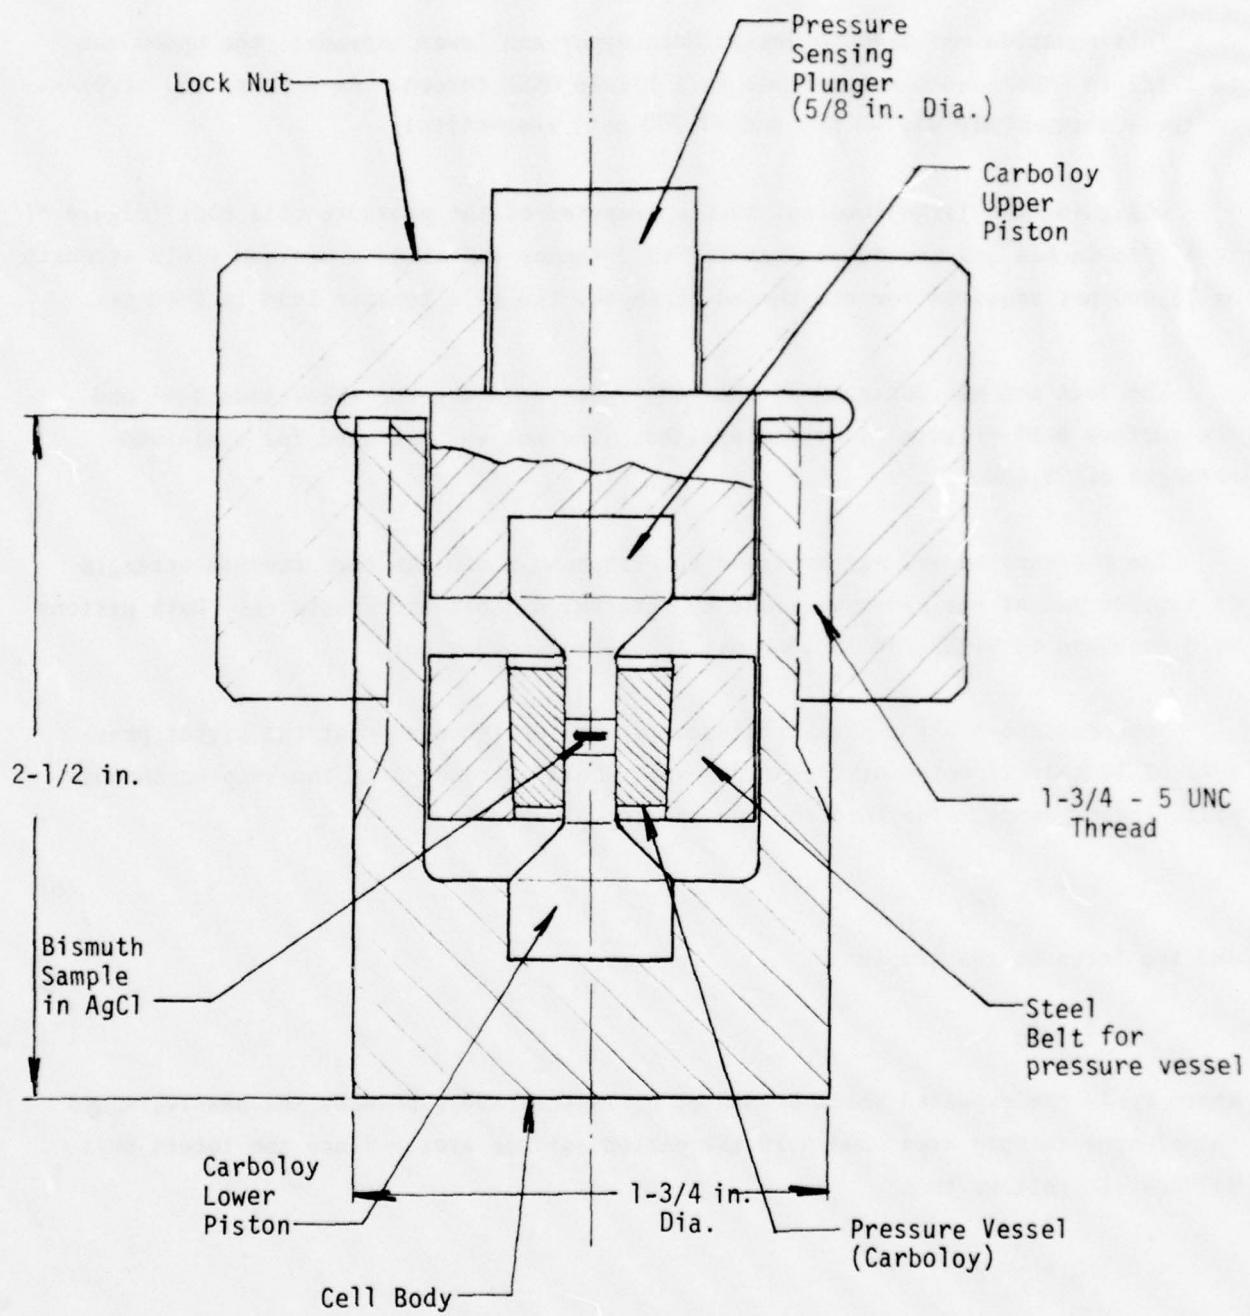
Figure 7. Bismuth element pressure cell.  
(Not to scale)

The same process was applied to the bismuth pressure cell, but upon the third loading the pressure vessel burst. The reason for this is the following: because of our tight schedule, the manufacturer had been unable to deliver the pressure vessel belt (see Figure 7). We decided to try the gauge without the belt, hoping that the Carboloy would resist the static load. When it burst, the press force had reached 5400 pounds, which corresponds to an internal cavity pressure of 13.6 kbar. We decided to keep the RbCl pressure cell number R7.5 for laboratory experiments. Therefore, only seven pressure cells were installed in the field: four MOV and three RbCl.

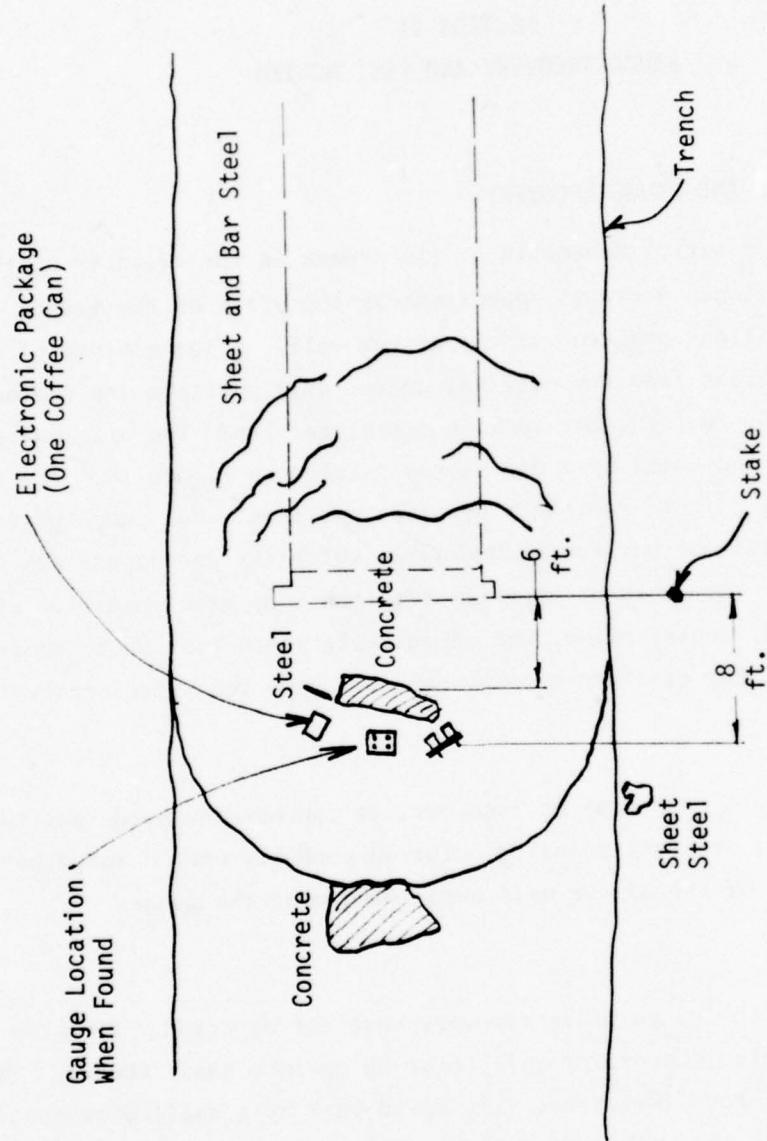
Figure 10. Post-detonation trench and crater.

Figure 10 shows an aerial schematic of the trench in the vicinity of the driver wall after the detonation. A crater approximately the width of the trench is shown centered about the original position of the driver wall. A large block of concrete was found some 4 to 6 feet from the original driver wall position and another large block was found some 33 feet further back on the crater lip. The original position of the driver wall is indicated by a dot marked "stake" in Figure 10. The gauge plates were found some 8 feet from their original position. One gauge plate was found in a vertical altitude but facing backward, while the second one was found lying flat facing up. They were at approximately their original position with respect to the vertical center plane, and approximately one foot above their original depth. One can containing electronic components was also recovered nearby the gauge plates (see Section VIII).

From the gauge plate positions at recovery, it can be concluded that they were driven back some 8 feet and that tumbling occurred probably over a large part of that distance. Chunks of the driver wall were found near the gauges.

The conditions of the gauge plate recovery were not expected. From the T-3 event, we had not expected the driver wall to break up into small chunks. The T-3 wall was found nearly intact (Reference 17), moved back by a small distance, and slightly inclined toward the back. We had placed our gauges in the T-5A experiment at the position indicated in Figure 9 in the hope that a similar condition as in T-3 would occur. As will be described below, we believe that this motion was responsible for the observed pressure cell deformation (see Section VII).

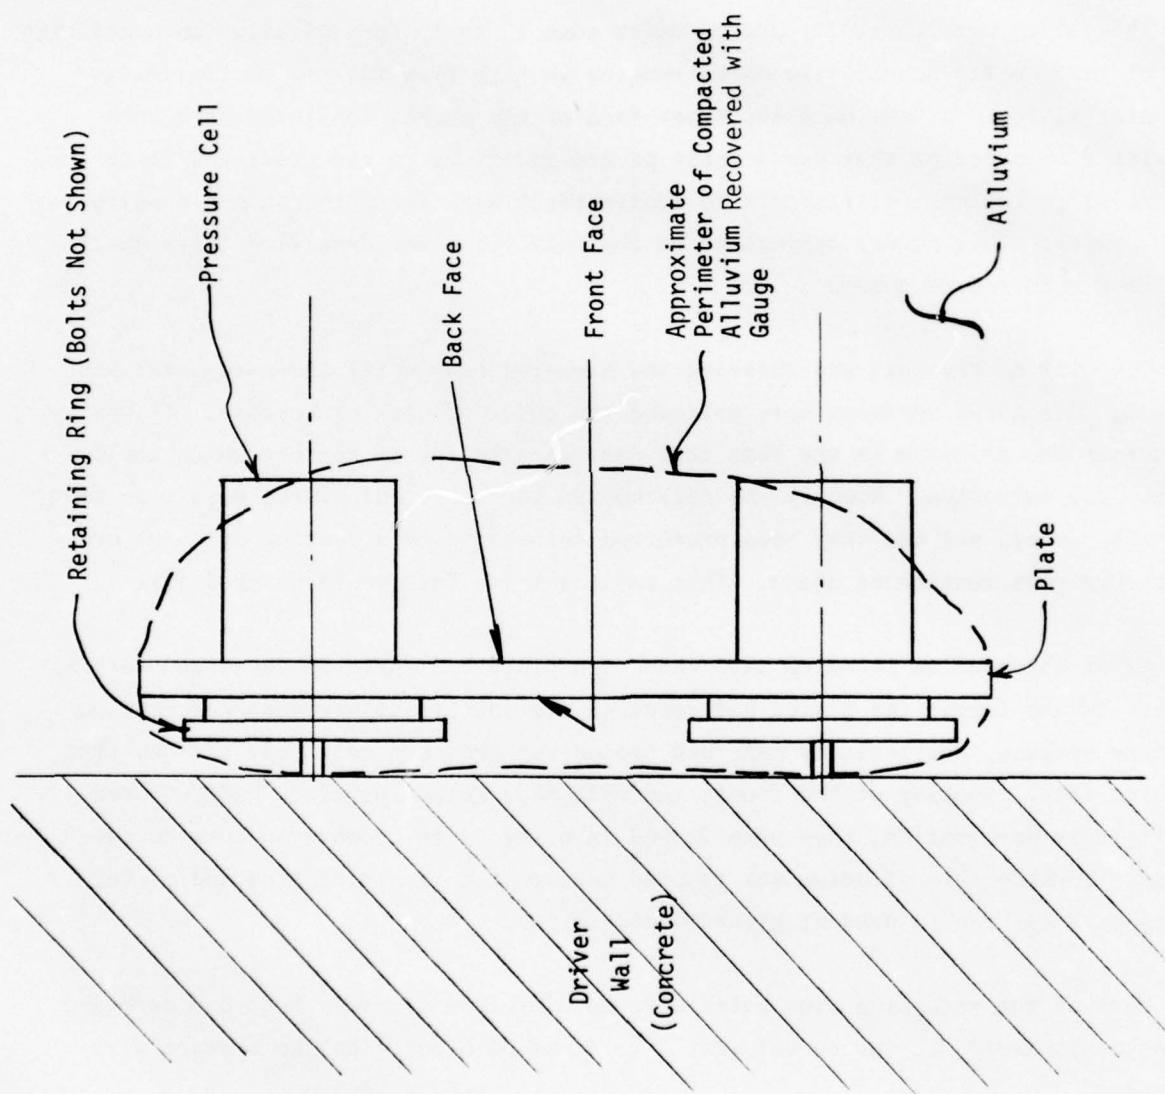
The gauges were initially packed under some 12 to 15 feet of alluvium containing lots of small milky quartz-like rocks ranging in size from microns to centimeters. The material found at the back and front face of the gauges consisted of a hard granular fine material that was densely packed and stuck to the steel and in cracks. Many small inclusions (millimeters to centimeters) were found to contain a white dense powder. This powder appears to be the pulverized and densified milky quartz-like rock referred to above.

Figure 11. Gauge with compacted alluvium. (No scale)

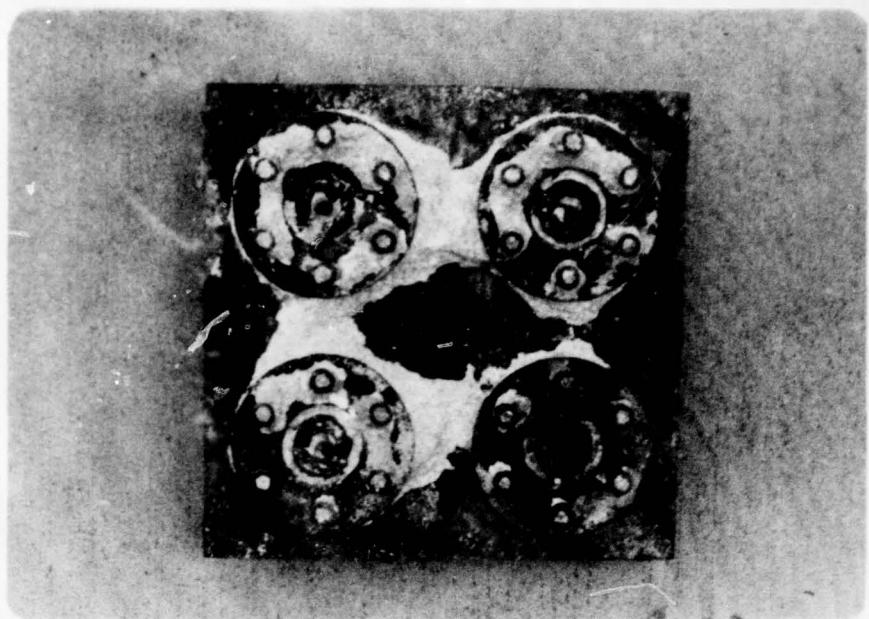
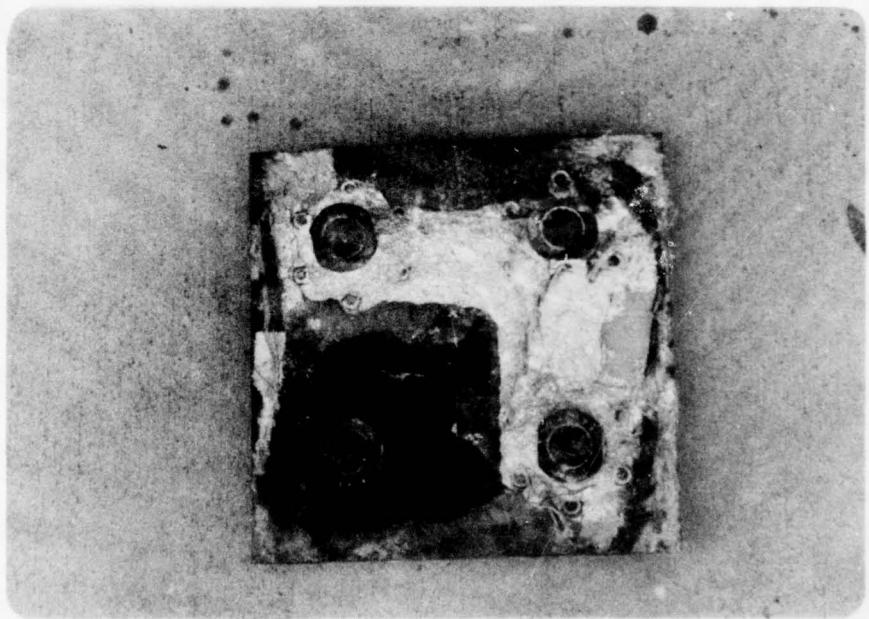
The bulk of the soil was chiseled and hammered away until the bare metal was exposed. All metal surfaces were corroded the color of dark brown rust. It was found that the alluvium in the Yuma test area is alkaline in content which would explain the corrosion. None of the cell bodies nor the steel plates were made from stainless steel, nor had they been protected beforehand by a coating of paint or other corrosion resistance agent. This treatment was felt to be unnecessary.

Figure 12a. Gauge (MOV) front view with most alluvium removed.

Figure 12b. Gauge (MOV) back view with most alluvium removed.

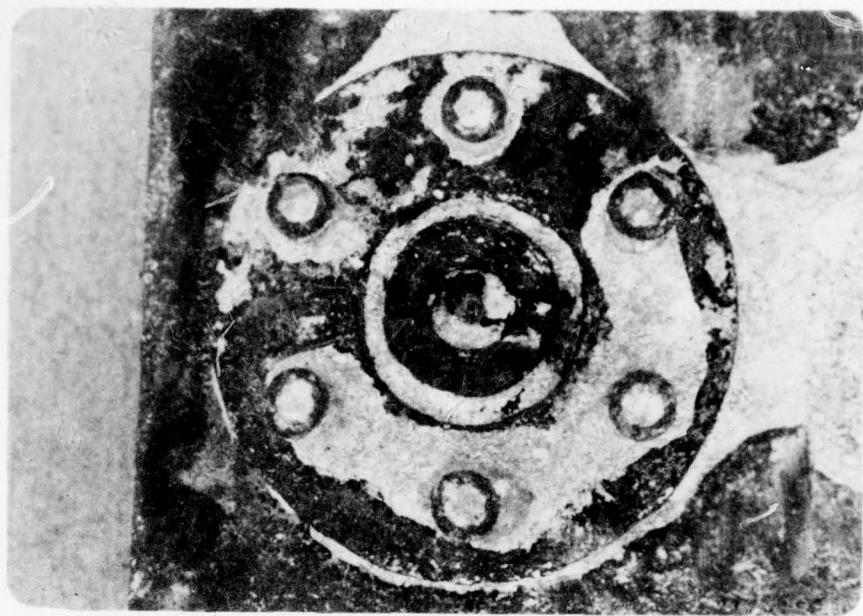
All pressure sensing plungers were deformed to varying degrees. Some had suffered axial compression with lateral wall barreling, others the same effect plus

Figure 13. Close-up of front face of pressure cell.

bending. None were so deformed that the diameter at the front edge could not be measured. Such measurements agreed with the values given in Table 1.

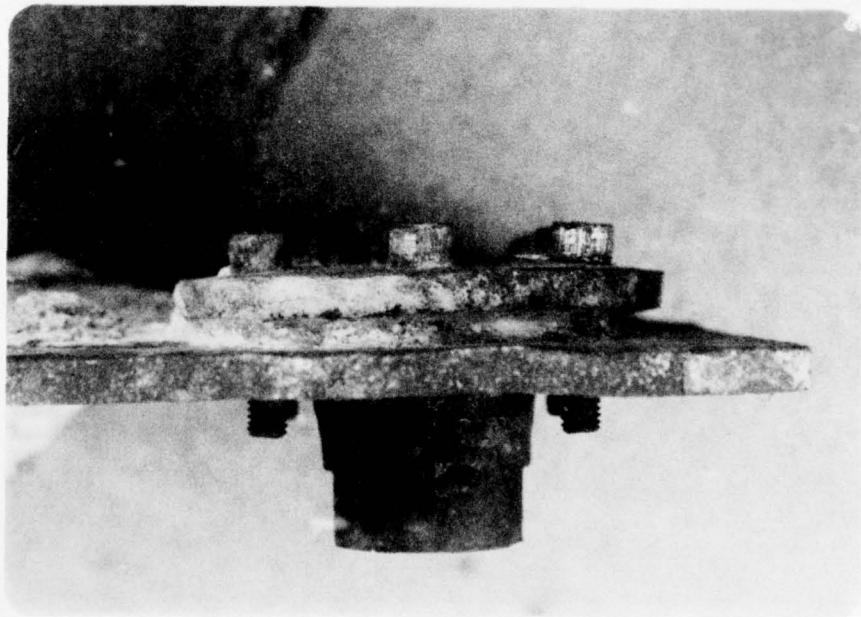
Figure 14. Side-view of pressure cell with nuts and lockwashers removed.

Looking at the rear side, the cell bodies had suffered 1/4 to 3/8-inch axial deformation due to compression. This axial shortening caused a good deal of radial barreling. It turned out that during disassembly, the barreling process had occurred along the entire cell body length and caused the holes in the plate to be enlarged, also reducing the size of the bolt holes around it. This decrease in the bolt hole size prevented them from being removed. The plate material surrounding the hole was deformed into a dish around most of the cell body periphery.

The retaining ring was found to be deformed to produce a convexity outward with the bolts bent outward. The cell body flange had been severely squeezed and thinned out as shown. The lock nut was also deformed but only that portion that remained outside the cell body. The steel plate near the body was generally deformed with a curvature as shown. This curvature was only along a portion of the plate around the body. These deformations can be seen in Figures 14, 17, and 18.

From the back, the deformation was mostly axial, again as seen from Figures 14 and 18. The upper pistons were found shortened by amounts given in Table 9, with the large diameter section that stops against the lock nut to have been "extruded" to fill the lock nut volume. No shear marks were found on the lock nut threads. The lower piston had moved toward the front with the threads suffering no shear. However, the piston and shoulder were found more or less severely deformed. The pressure vessel was moved toward the front by the stop surface G-G' (see Figure 24) in the cell body. When the pressure vessel stopped against the lock nut, the pressure vessel produced the curled lip at the stopping plane G-G'. The body in collapsing expanded radially inward and outward. The inward expansion stopped against the pressure vessel while the outward expansion continued against the steel plate, enlarging the hole and also bulging out past it as indicated by diameter C in Figure 24. The upper surface of the pressure vessel stopped against the upper piston surface H-H' (see Figure 24) with the corner engaging the lock nut and producing an angle bevel. In terms of the sequence just described, it is significant to note here that:

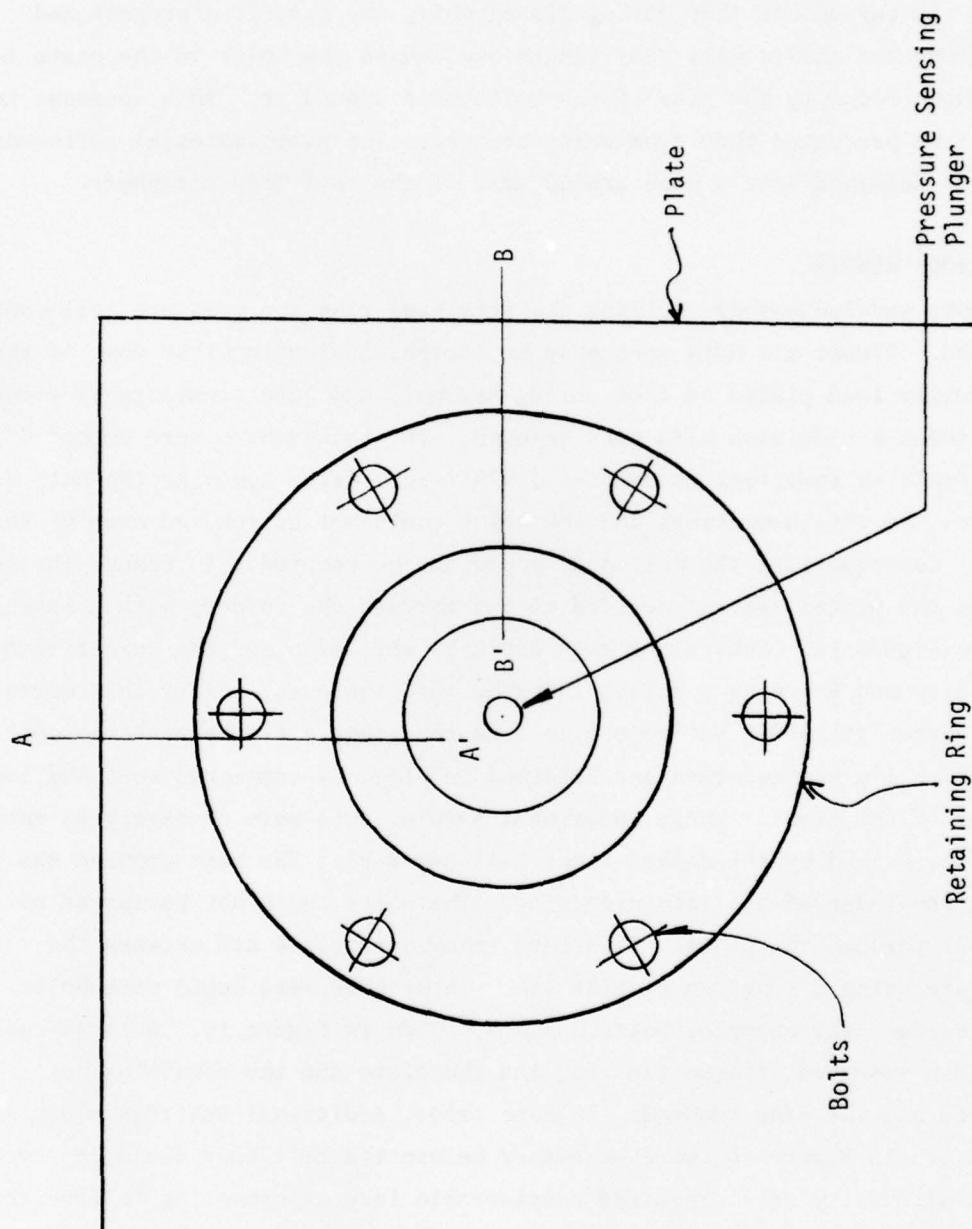
The nuts and lockwashers holding the retaining ring and pressure cell bodies were removed. Almost all nuts were easy to loosen, indicating that most of the initial tensile load placed on them during assembly had been considerably reduced. Figure 14 shows a side view with nuts removed. The lockwashers were embedded in the steel plate by sometimes as much as 0.020 inch. After removing the nuts and the washers, the retaining rings and the bolts could not be removed even by severe hammering. Consequently, the cell body would not be removed. To remove the cell bodies from the plates, it was decided to cut through the corners with a hacksaw as shown in Figure 15. Cuts along A-A' and B-B' were made and the corner removed by hammer blow and by using a chisel inserted into the cuts. After this operation, the gauges still did not come free from the gauge plate because the cell body retaining lip was deformed and retained in place by compacted soil and large deformation of the steel. Thus, additional angular cuts were necessary as shown in Figure 16, marked by the dashed lines A-A' and B-B'. The next problem was to remove the remainder of the retaining ring. The bolts could not be turned nor hammered out through the plate. Therefore, they were sawed off between the ring and the plate using a tungsten carbide saw. These cuts were begun with bolts nearest the edge; for example, bolts C and D, shown in Figure 16. A large road pick was then inserted between the ring and the plate and the remaining bolts were snapped and the ring removed. In some cases, additional cuttings along A-A' or B-B', shown in Figure 16, were necessary before the cell body could be removed. Their removal usually still required considerable lateral hammering to free them from the plate. In one case, the retaining ring was removed without cutting into it.

Figure 15. Saw cut positions to remove pressure cell.

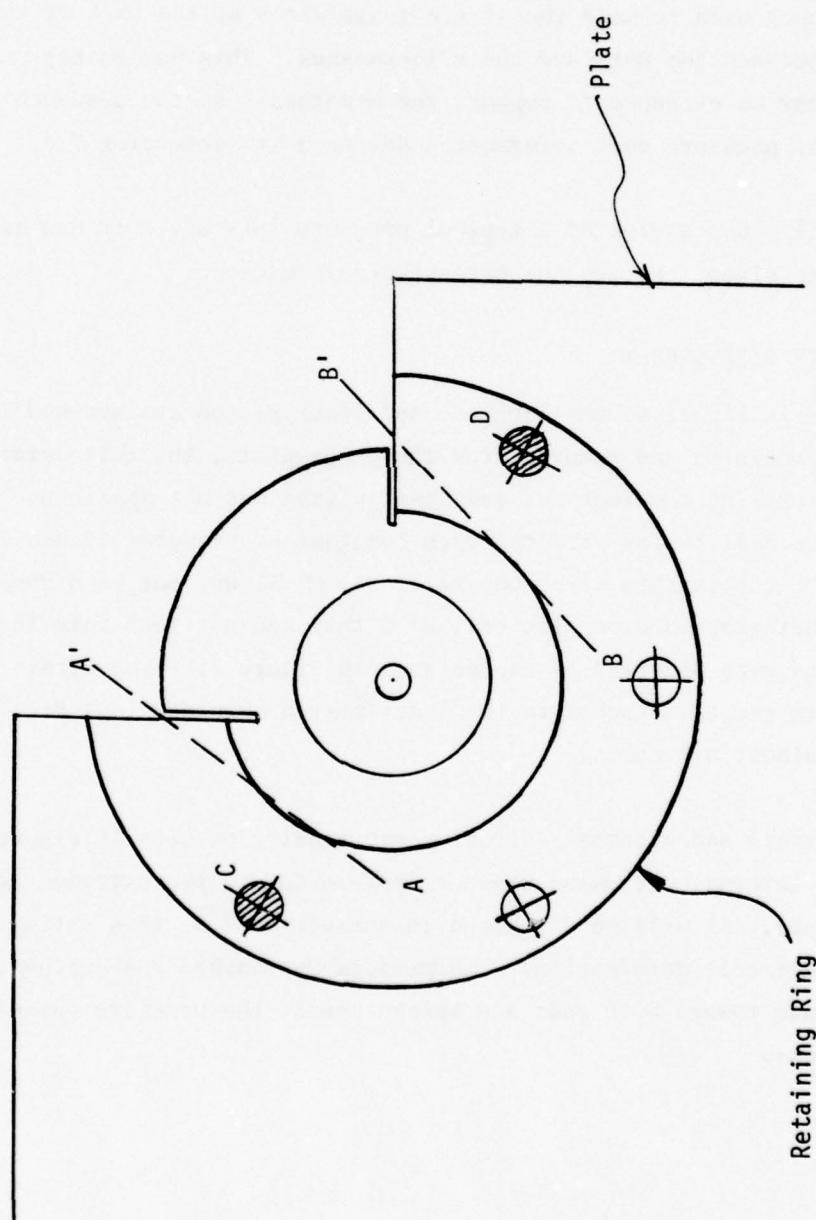
Figure 16. Additional saw cuts to remove pressure cell. Bolts C and D were also cut.

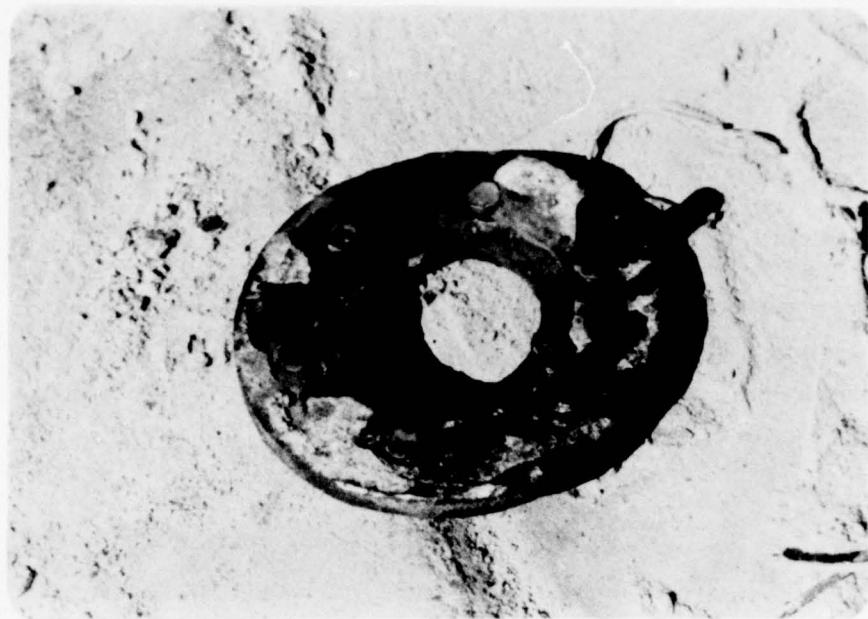
Most of the retaining ring bolts were more or less severely bent and deformed. During disassembly, it turned out that 2 to 3 out of 6 bolts on the average were sheared.

Figure 17 shows this ring. Note the extensive depression produced by the pressure cell body lip (see Figure 6). In this photograph, two bolts on the left were found sheared while the inner two were sheared during disassembly. The remaining two are a rare case where the bolt could be removed from the plate without cutting or shearing.

Figure 17. Typical removed retaining ring.

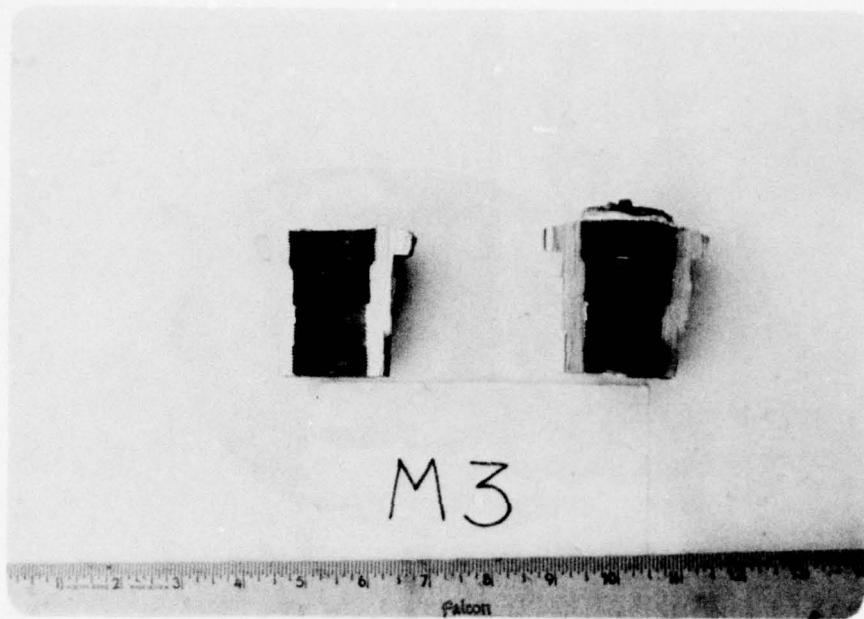
Figure 19. Sectioned M3 cell.

It will be recalled that four metal oxide varistor (MOV) pressure cells were installed in the T-5A field experiment. These samples were enclosed in AgCl pills whose sizes are given in Figure 8. Because of the pressure cell deformation, the MOV pills were reduced from their original 0.25-inch thickness to a range varying from near zero to 0.060 inch in thickness. In the course of disassembling the MOV pressure cells, as described in subsection 6.4, two MOVs, Nos. M7.5 and M3, were found crushed beyond usefulness.

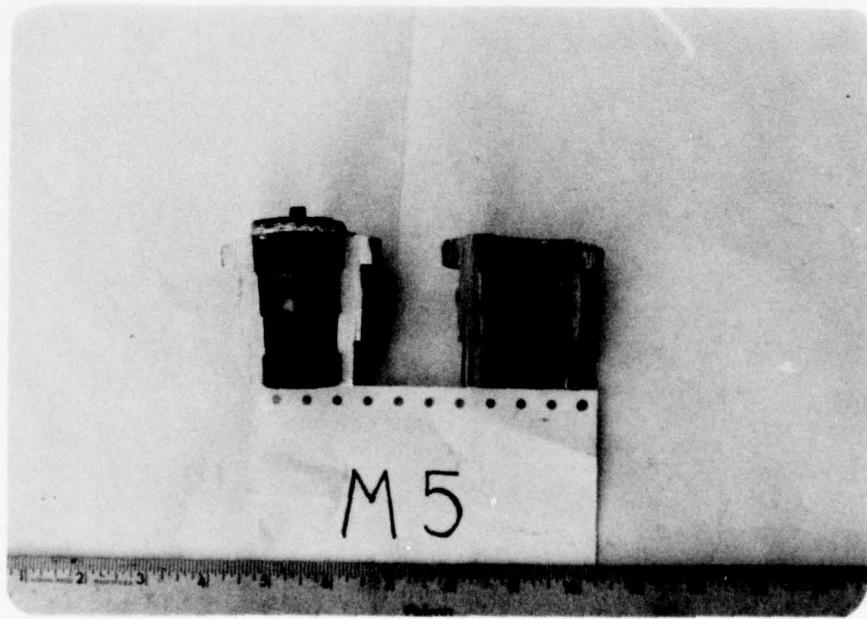
Figure 20. Sectioned M5 cell.

Sample No. M5 was recovered from the remains of the AgCl pill. This pill had a final dimension of approximately 0.065 inch in thickness. The MOV sample was slightly wedge shaped with the greatest thickness of 0.063 inch and the thinnest side 0.033 inch. Its appearance was no longer circular but elliptical, with major and minor diameters of 0.300 inch and 0.255 inch, respectively. Thus, it appears as if some of the reduction in thickness went into increasing the overall diameter. From marks near the thick side of the wedge, and from its position found in the AgCl, it appears that the following process caused the deformation. As the piston faces approached one another when the cell body and other components suffered plastic deformation, they began moving out of parallelism, thereby promoting AgCl extrusion preferentially toward one side of the piston. The extrusion process entrained the sample in the direction of greatest flow and finally jammed it against the pressure vessel wall, causing the flow to deform the sample into its observed elliptical shape. The sample voltage-current characteristic was measured and it was found that

at 90 volts, the current began increasing exponentially with time from a few nanoamps to 162 nanoamps when the measurement was terminated. This runaway condition is due to the fact that during the deformation process, cracks must have developed providing paths for the current to flow in preference to the bulk material (Reference 11).

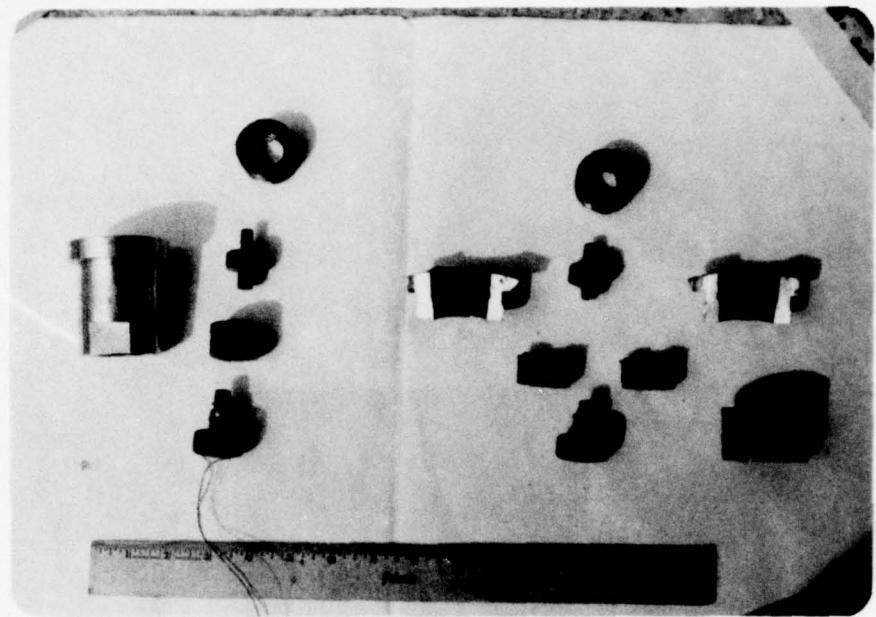
Figure 21. Comparison of undamaged and used pressure cell.

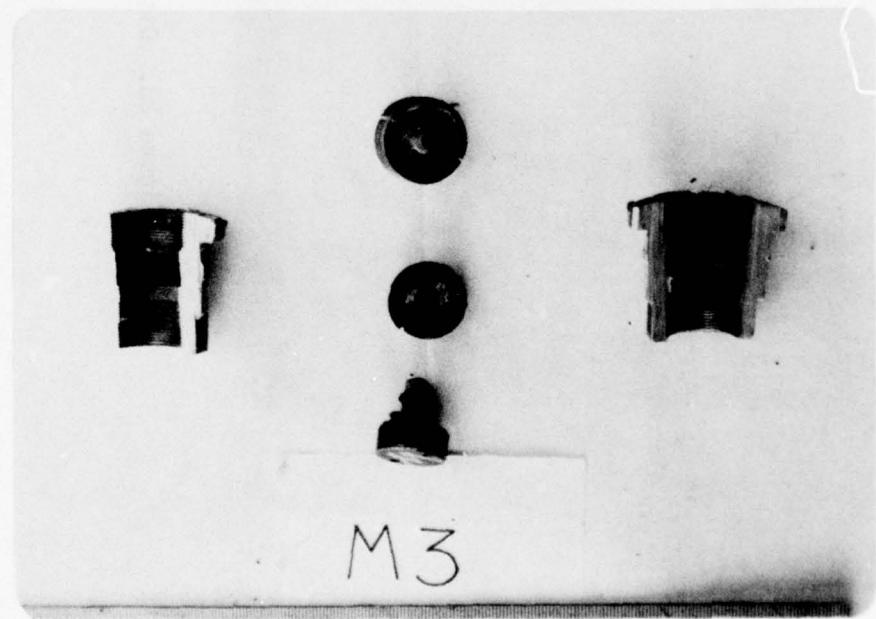
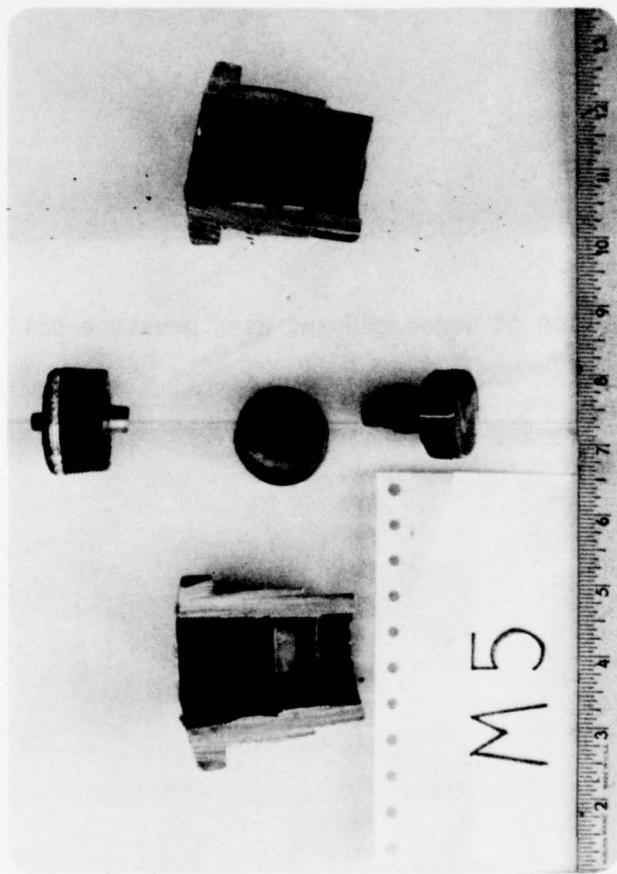
The internal and external corrosion can readily be seen in Figures 22 and 23. However, the internal corrosion was more severe due to the extruded AgCl from the pressure vessel. As will be discussed in subsection 7.3, this extrusion occurred during pressure cell deformation. The pistons approached one another, causing the AgCl to extrude toward both ends and spread across the pressure vessel end faces and the pistons.

Figure 22. Disassembled M3 cell.

Figure 23. Disassembled M5 cell.

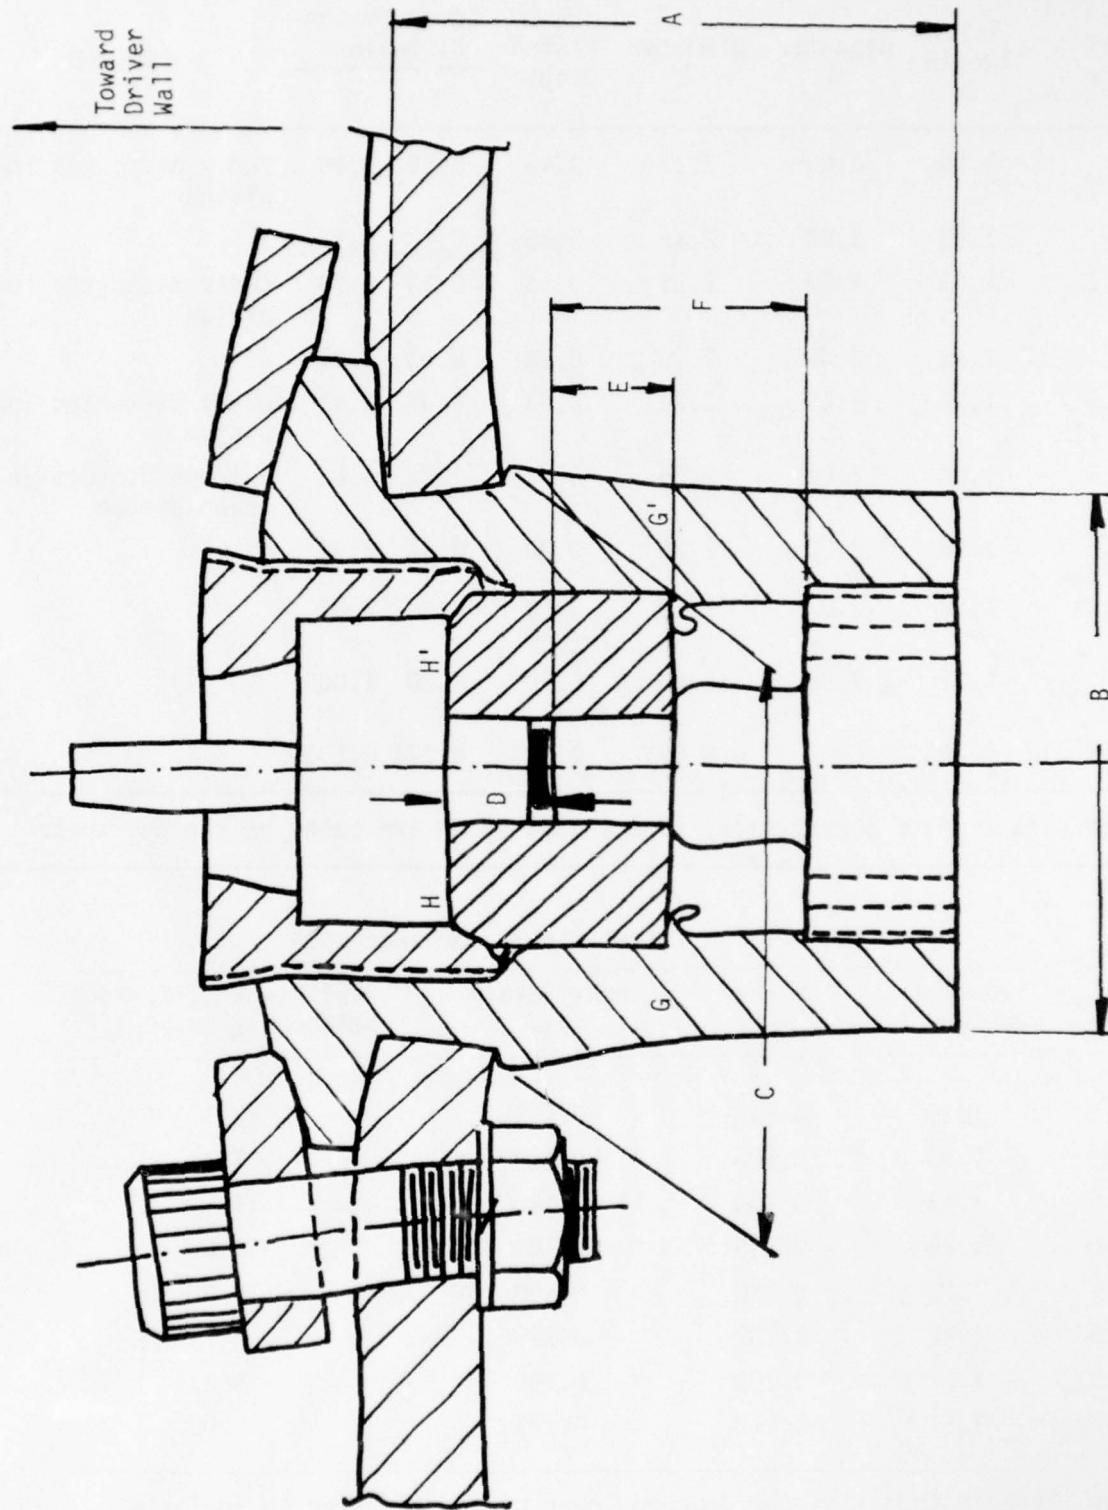
We will now describe what we believe to be the sequence of events that caused the observed deformations. Figure 24 shows a composite of deformation for all cells. An important distinction must be made between the deformations at the front of the gauge plate and the deformation at the back. The deformation at the back and the general appearance of the internal components gives the clue as to the sequence of events to be described. First, we describe the pressure cell appearance.

Figure 24. Composite of pressure cells after test (free-hand drawing).

What most likely happened is the following. After the shock passed and registered on the samples, the concrete driver wall and alluvium packed between it and the gauge plate pushed the plate and cell back against the alluvium in back of the plate. The driver wall disintegrated and the mass velocity produced the deformation seen at the front. This was followed by the plate being set in motion relative to the alluvium and then driven into the alluvium some distance. The initial velocity was very high, decaying rapidly over a relatively short distance. This motion caused the cell body to collapse axially, pushing the lower piston into the pressure vessel displacing the sample pill toward a new position further forward. When the pressure vessel stopped against the lock nut, the lower piston continued to move and AgCl extrusion began. Also, the upper piston began to "extrude" into the volume of the lock nut. Finally, the cell body continued its motion until inward and outward radial expansion stopped against the pressure vessel lateral wall and the hole in the plate. This total deformation process occurred very rapidly, while the velocity was still quite high, and consequently over a short distance. The remaining distance covered by the gauges to their resting place produced no further plastic deformation. Tumbling thus began early in the motion and probably while the crater scouring process was going on.
